Lincoln Mark VII 1984 CFI EGR Cooler Hose Repair

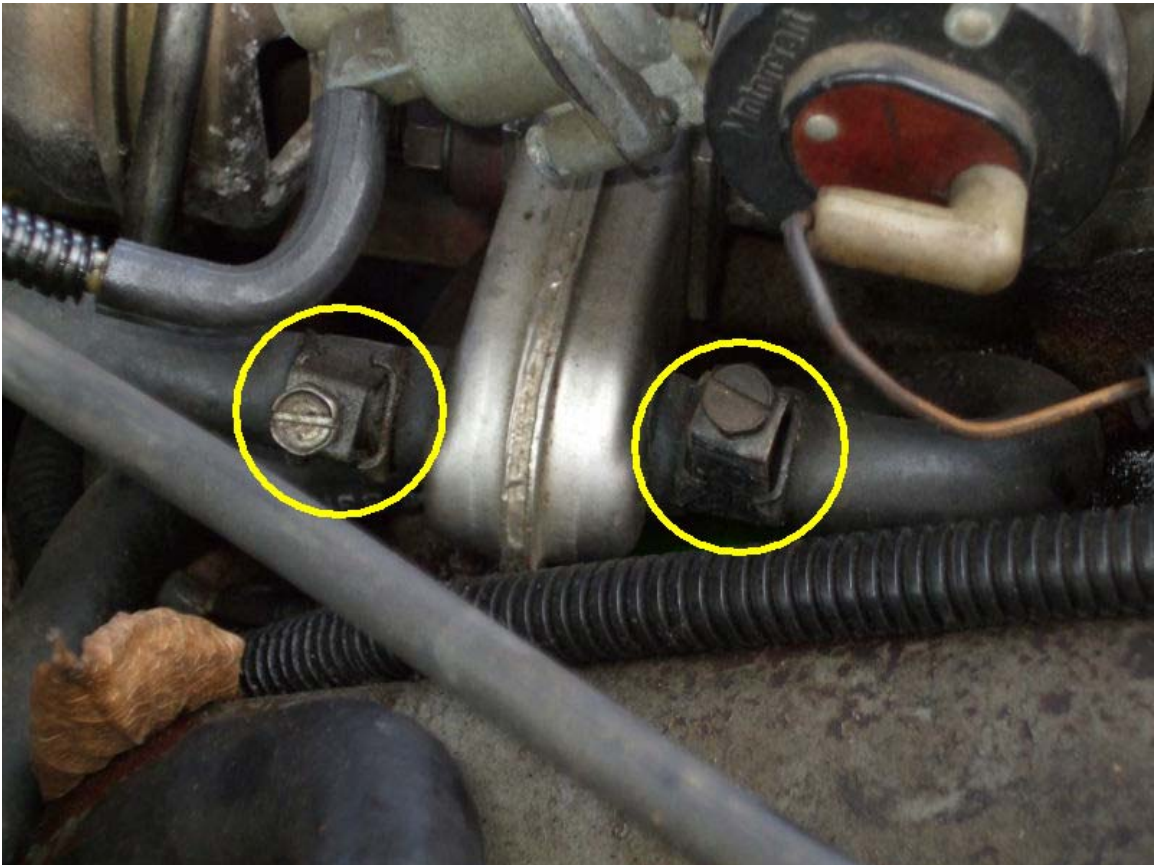
The Exhaust Gas Recirculating (EGR) System on our Central Fuel Injected (CFI) Mark VII's, have a sandwich type cooler. Utilizing engine coolant, this aluminum device is quite efficient for it's size. It is often removed or disconnected by owners living in areas that do not require EGR equipment on their vehicles. This article was written due to finding anti-freeze sitting on top of the lower intake manifold, and then finding the cooler's hoses were worn and brittle at the ends. Though hose replacement is best, the quick fix is shown below.
