Lincoln Mark VII

1988 - 1989

Ignition Switch

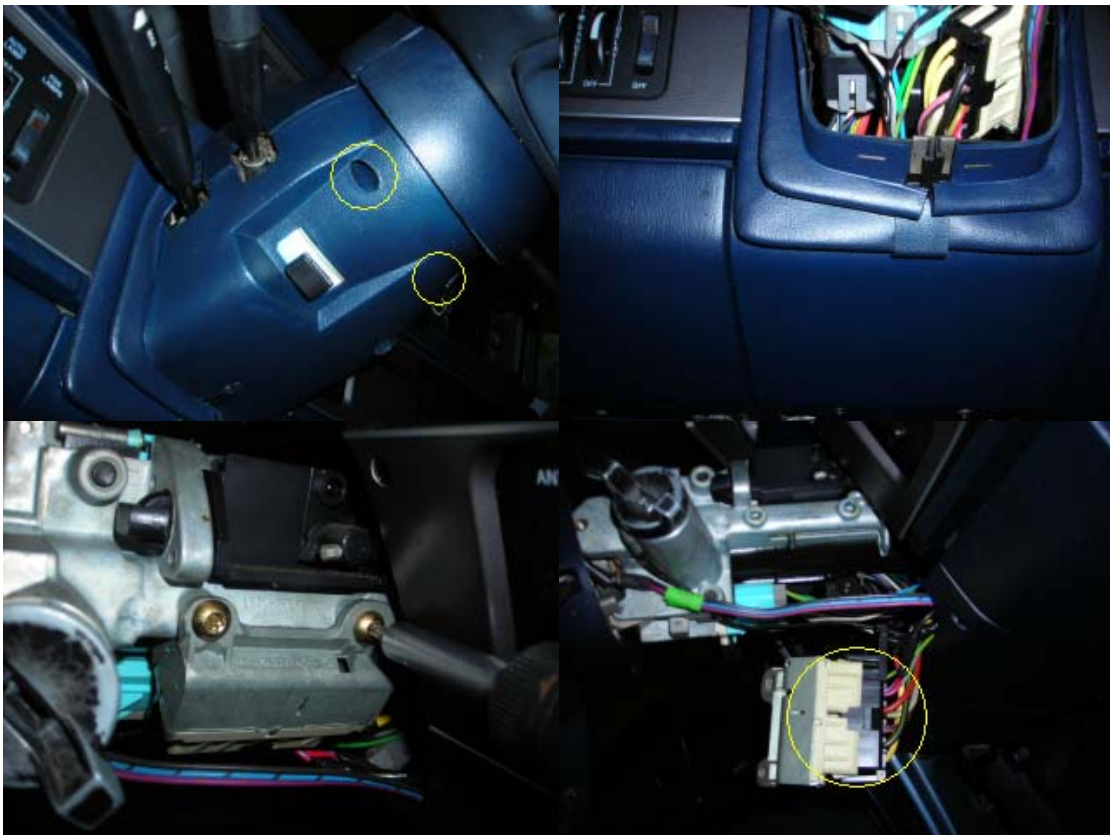
The ignition switch is mounted on the lock cylinder housing and is controlled by the lock cylinder through a pin, which is part of the actuator assembly.

1. Remove the steering column shroud by removing the two screws holding the upper and lower shroud halves together.
2. Remove the collar by pulling it away from the dash.
3. Remove the two ignition switch bolts using a super torx T-25 driver.
4. Disconnect the ignition switch connector.

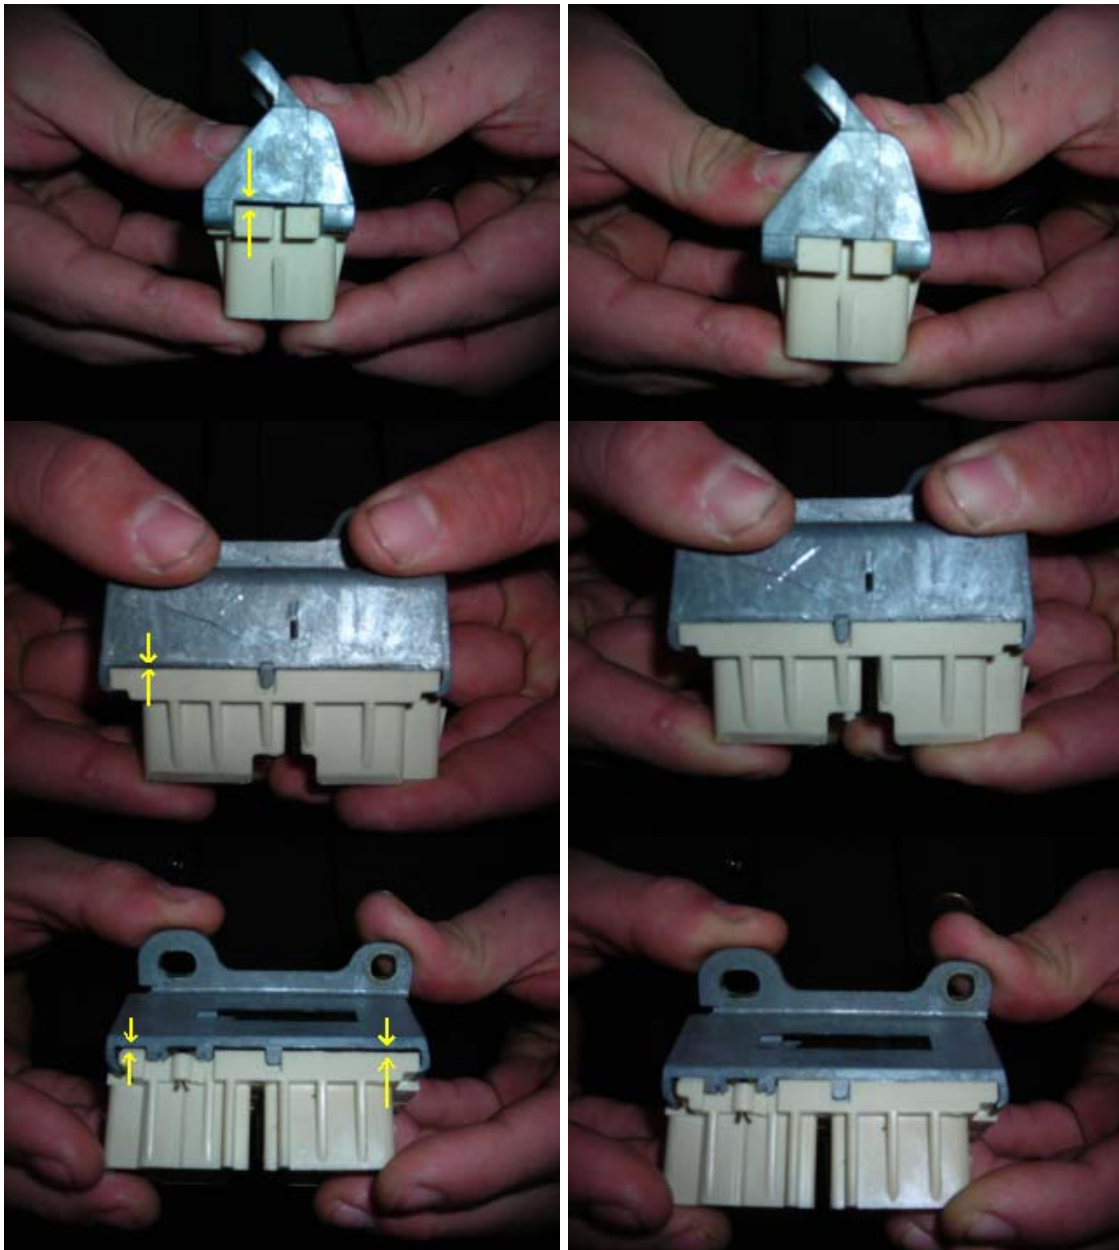
Bad ignition switches have a gap between the plastic and metal halves. This gap raises the resistance in the battery, accessory, and ignition circuits causing them to malfunction and fail.

Good ignition switches have no gap.

This switch came out of a 1988 LSC with LESS THAN 28,000 miles on the odometer!
